Manhole Inspection Summary

Manhole # S31C__022MH

Insp Date: **8/8/08 12:01 PM**

Location Address: **300 w saratoga st**

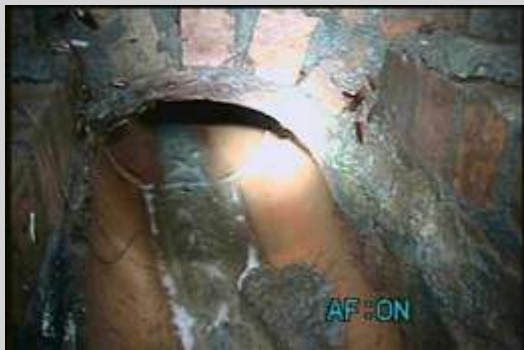
12 O'Clock Outflow

8 in. Circular Gravity Sewer
Pipe Out @ 12 O'Clock

Pipe Material: **Clay** ☐ Pipe Lined

Invert Depth: **13.82** (ft.) Flow Characteristics: **Slow**

Deposits: ☒ None ☐ Mud ☐ Sludge ☐ Debris ☐ Grease

Infiltration: **None** Pipe Seal Cond: **Unknown**

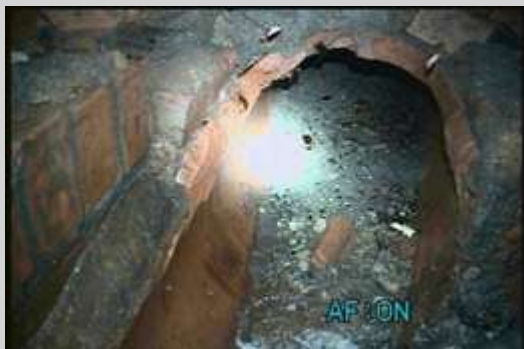
6 O'Clock Inflow

8 in. Circular Gravity Sewer
Pipe In @ 6 O'Clock

Pipe Material: **Clay** ☐ Pipe Lined

Invert Depth: **13.75** (ft.) Flow Characteristics: **Slow**

Deposits: ☒ None ☐ Mud ☐ Sludge ☐ Debris ☐ Grease

Infiltration: **None** Pipe Seal Cond: **Unknown**

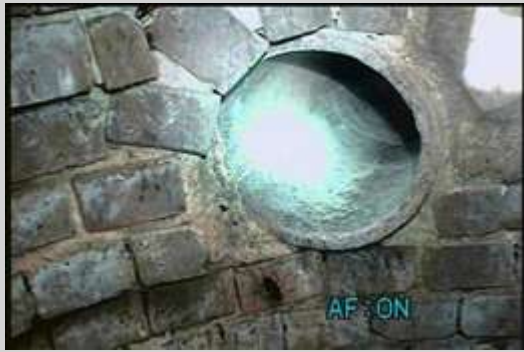
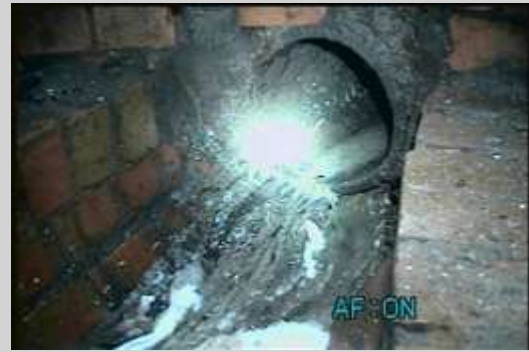
8 O'Clock Inflow

8 in. Circular Gravity Sewer

Pipe In @ 8 OClock

Drop In @ 8 OClock

Pipe Material: **Clay** ☐ Pipe Lined

Infiltration: **None**

Drop Condition: **Open**
